## IMAGES IN INTENSIVE MEDICINE

### Use of echo-contrast in the diagnosis of coronary fistula rupture<sup>☆</sup>

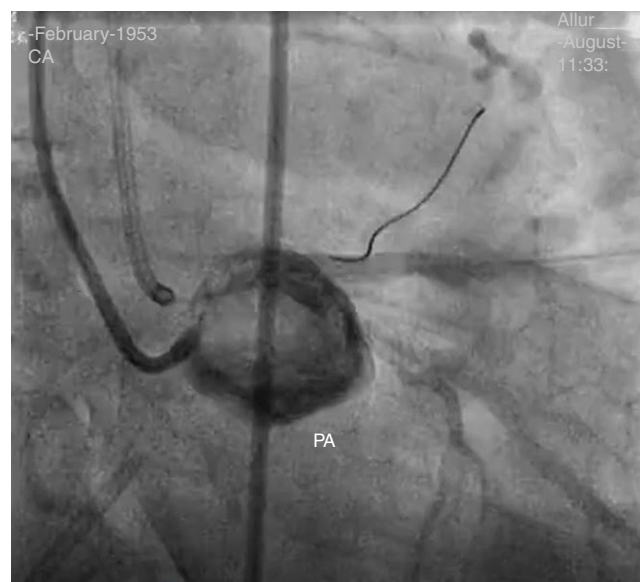
**Figure 2** The coronary angiography confirms the presence of pseudoaneurysm (PA) of the coronary fistula.

Seventy-six-year-old male with a prior history of chronic ischemic cardiomyopathy (percutaneous revascularization of left and right anterior descending arteries) and coronary fistula from common trunk to known right atrium who presents to the ER complaining of chest pain and posterior asthenia and progressive dyspnea of one-week duration. During his stay at the ER, the patient develops hypotension and severe desaturation, which is why he is admitted to the ICU where one transthoracic echocardiogram (TTE) procedure is conducted that confirms the presence of massive pericardial effusion of up to 4.3 cm ([video 1](#)). A pericardial drainage procedure is conducted and the TTE with systemic injection of 3 ml of sulfur hexafluoride (Sonovue<sup>®</sup>) confirms the presence of bubbles from this solution in the pericardium ([Fig. 1](#) and [video 2](#)). After stabilizing the patient and on suspicion of coronary fistula rupture, one coronary angiography is conducted that confirms the presence of pseudoaneurysm of the fistula ([Fig. 2](#) and [video 3](#)) as the possible cause for the bleeding that is later sealed. The patient was discharged from the hospital after six (6) days.
